GEOTECHNICAL INVESTIGATION

WEST DIMOND BOULEVARD UPGRADE Jodhpur Road to Sand Lake Road

PM&E Project No. 05-005

February, 2007

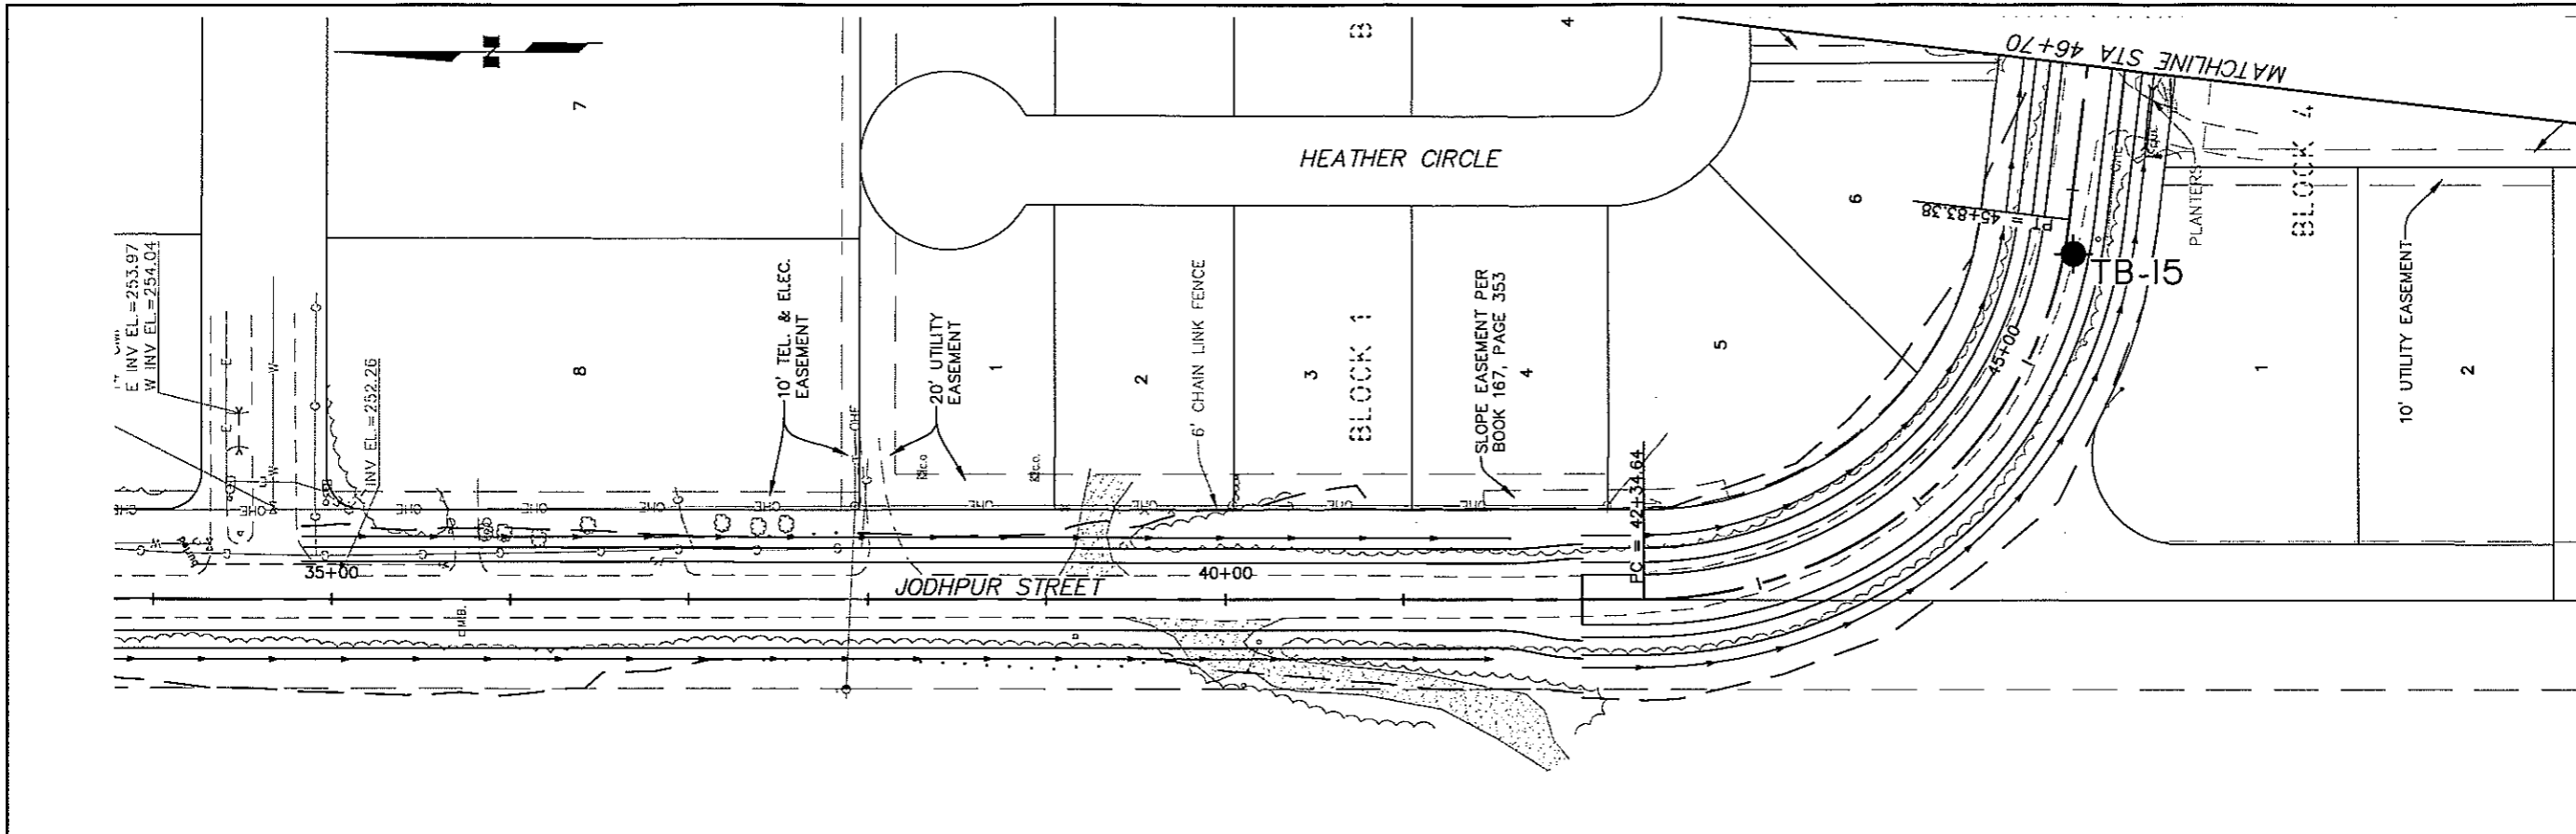
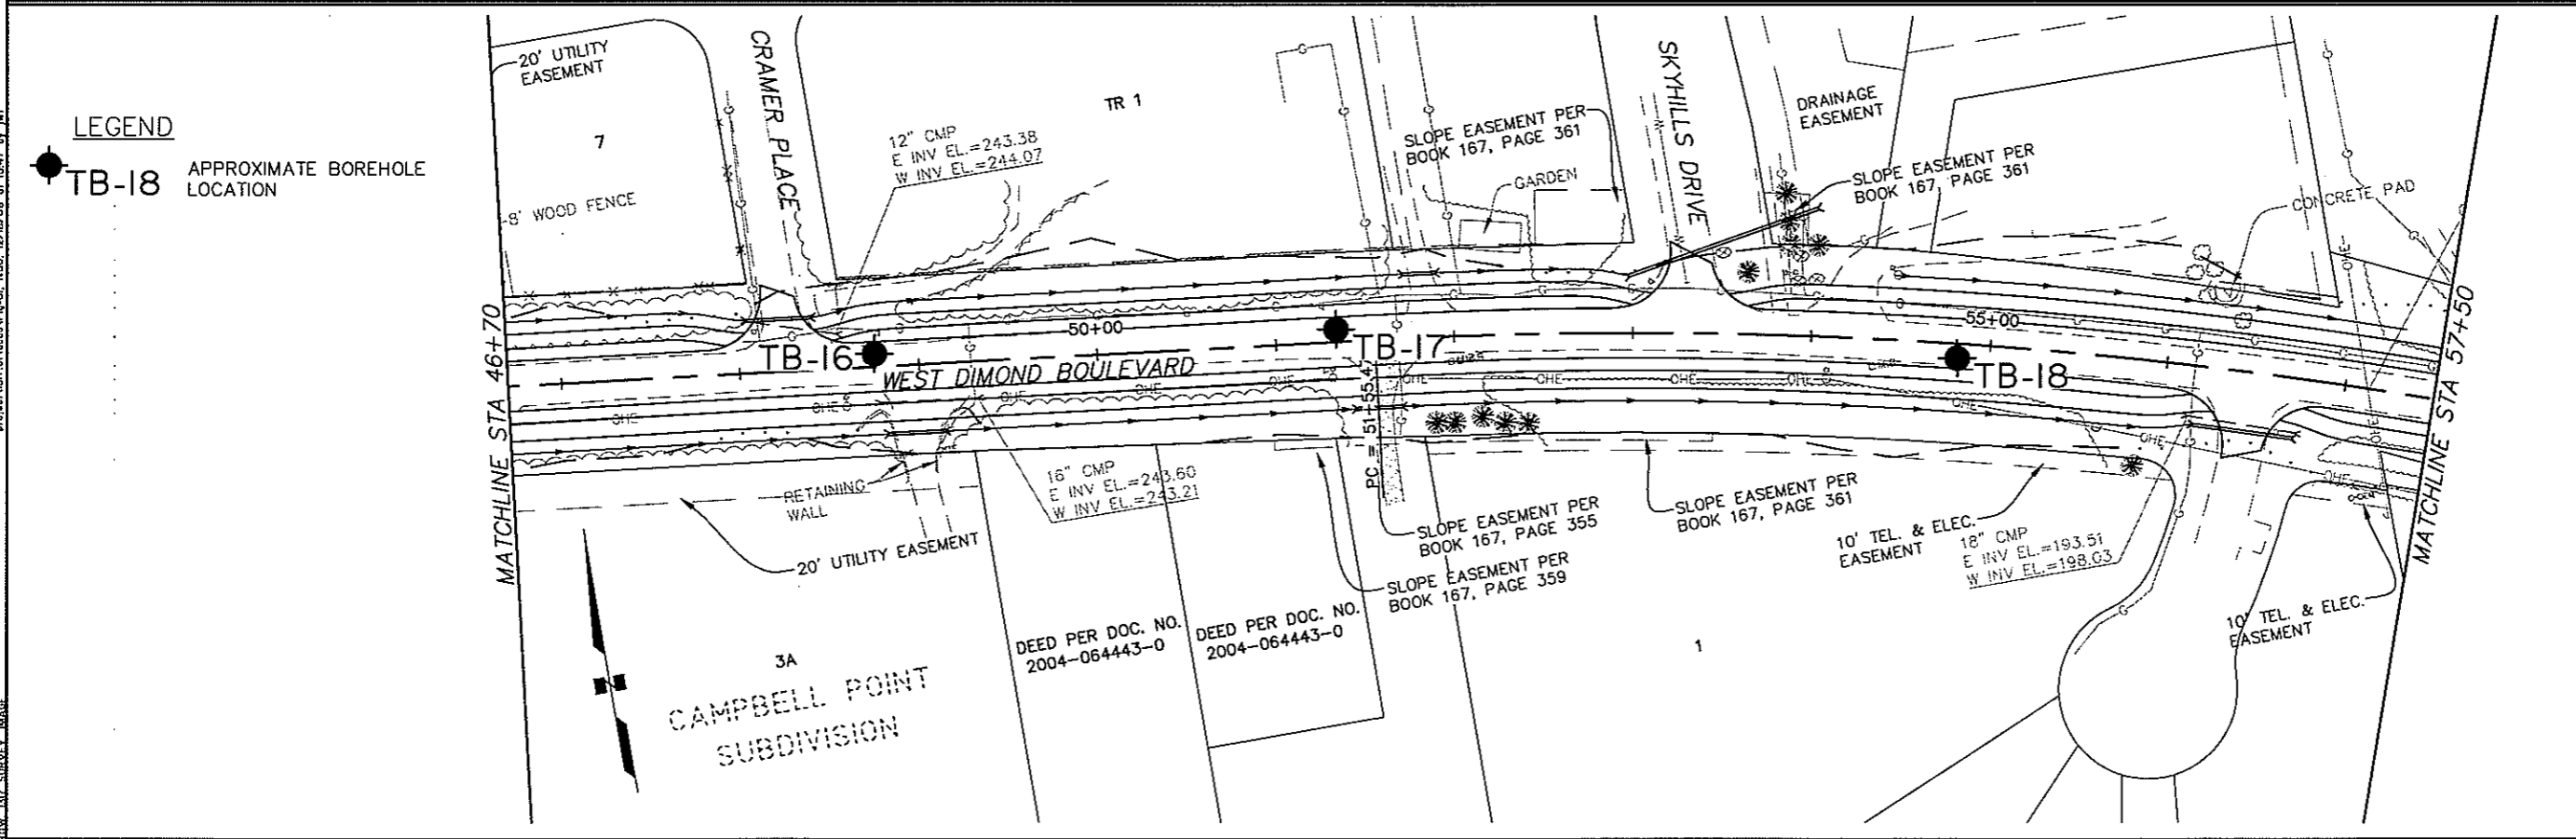
DEPARTMENT OF PUBLIC WORKS
 OFFICE OF THE MUNICIPAL ENGINEER
 05-04
 WEST DIMOND BOULEVARD UPGRADE
 JODHPUR STREET TO SAND LAKE ROAD
 BOREHOLE LOCATION MAP
 SCALE 1"=100' DATE 1/23/07 GRID PROJECT NO. 1317.01 DRAWING A-02

● TB-18 APPROXIMATE BOREHOLE LOCATION

Vicinity Map	A-01
Borehole Location Plans	A-02 thru A-04

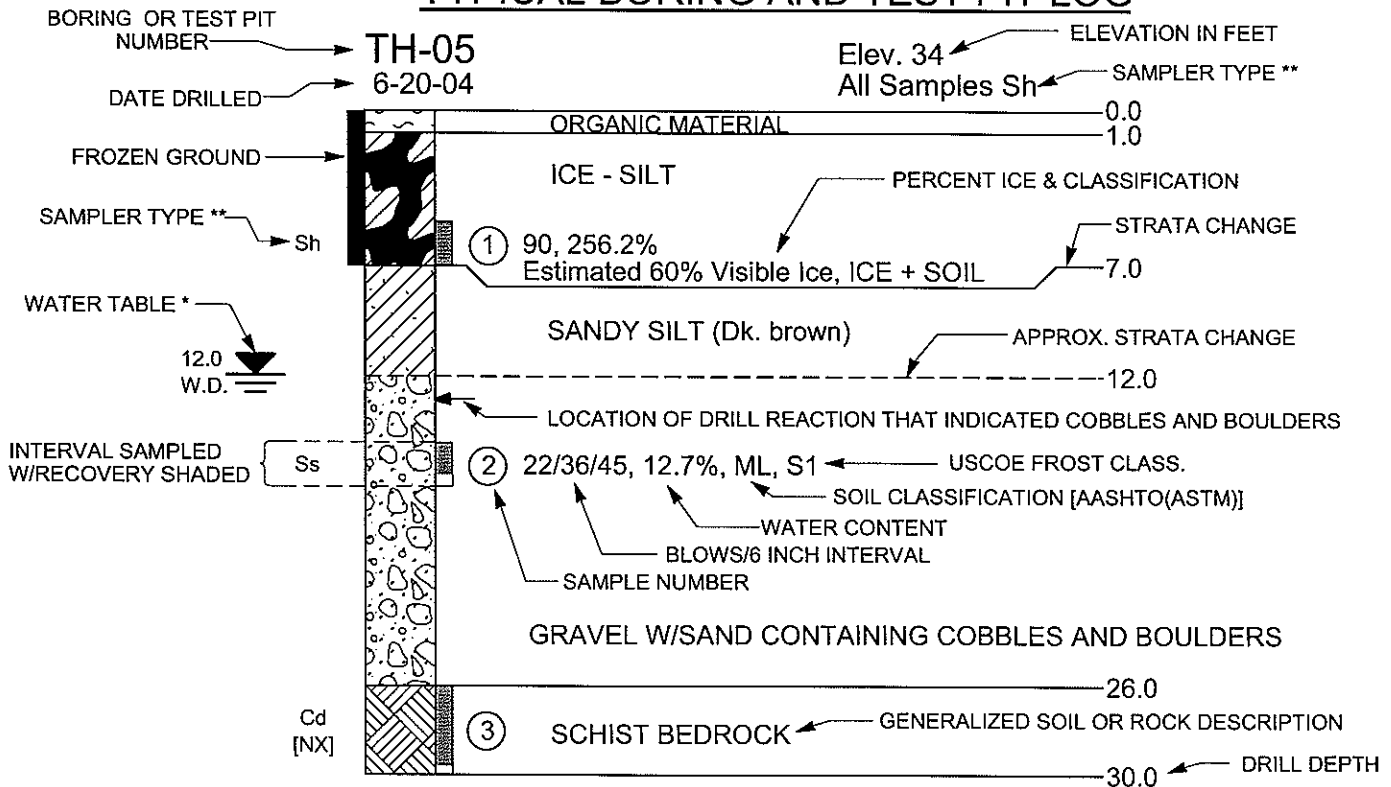
TYPICAL BORING AND TEST PIT LOG

* W.D. - WHILE DRILLING, A.B. - AFTER BORING, Ref. - SAMPLER REFUSAL
 ** - REFER TO SAMPLER SYMBOL (Ss, Sh, ETC.) FOR SAMPLER I.D. & HAMMER WEIGHT/TYPE
 NOTE: Water levels shown on the boring logs are the levels measured in the boring at the times indicated.

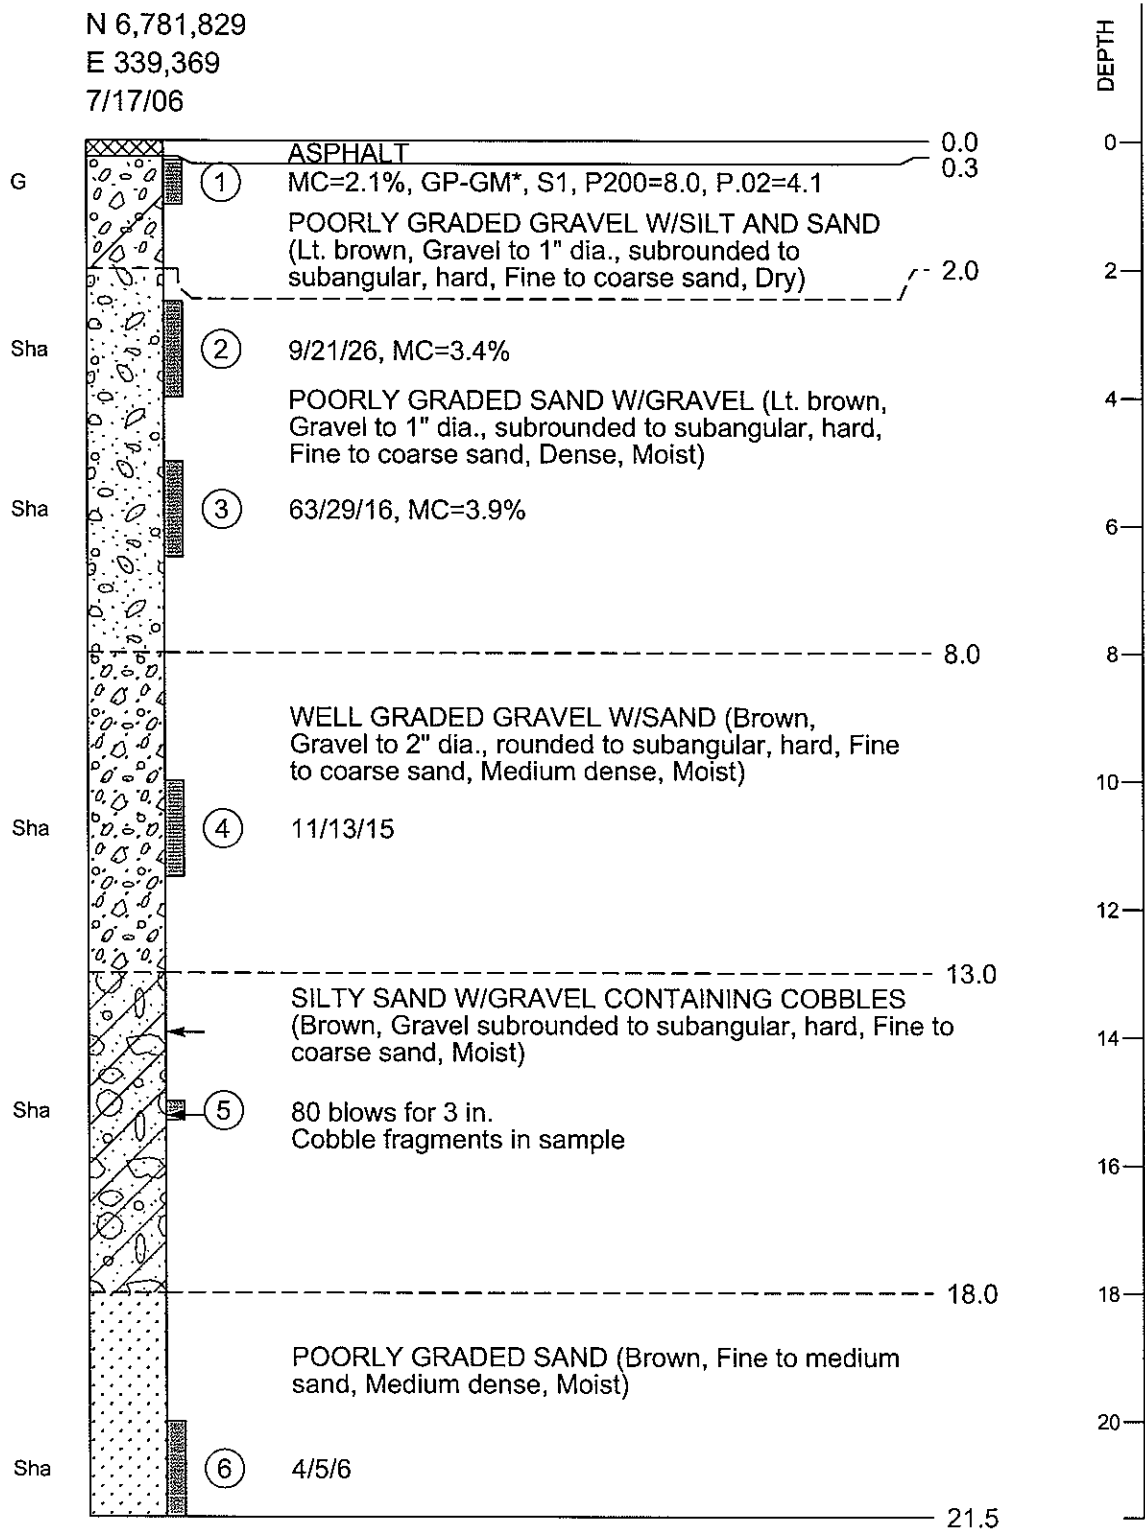
TB-01
 N 6,781,829
 E 339,369
 7/17/06

* Estimated Classification
 No groundwater was observed while drilling
 Coordinates are provided in UTM Format, WGS84 Datum, Zone 6V

Four test holes (TB-01 through TB-04) were drilled in this segment. The subsurface conditions in this segment generally consisted of at least two feet of granular fill over a generally granular subgrade. The granular fill consisted of well to poorly graded gravel with silt and sand to sand with silt and gravel. The P200 ranged from 8.3 to 9.0 percent. Moisture contents ranged from 2.1 to 3.1 percent. The subgrade mostly consisted of well to poorly graded gravel with silt and sand. In Test Boring TB-03, a 1.5-foot thick layer of silt was present below the fill material.

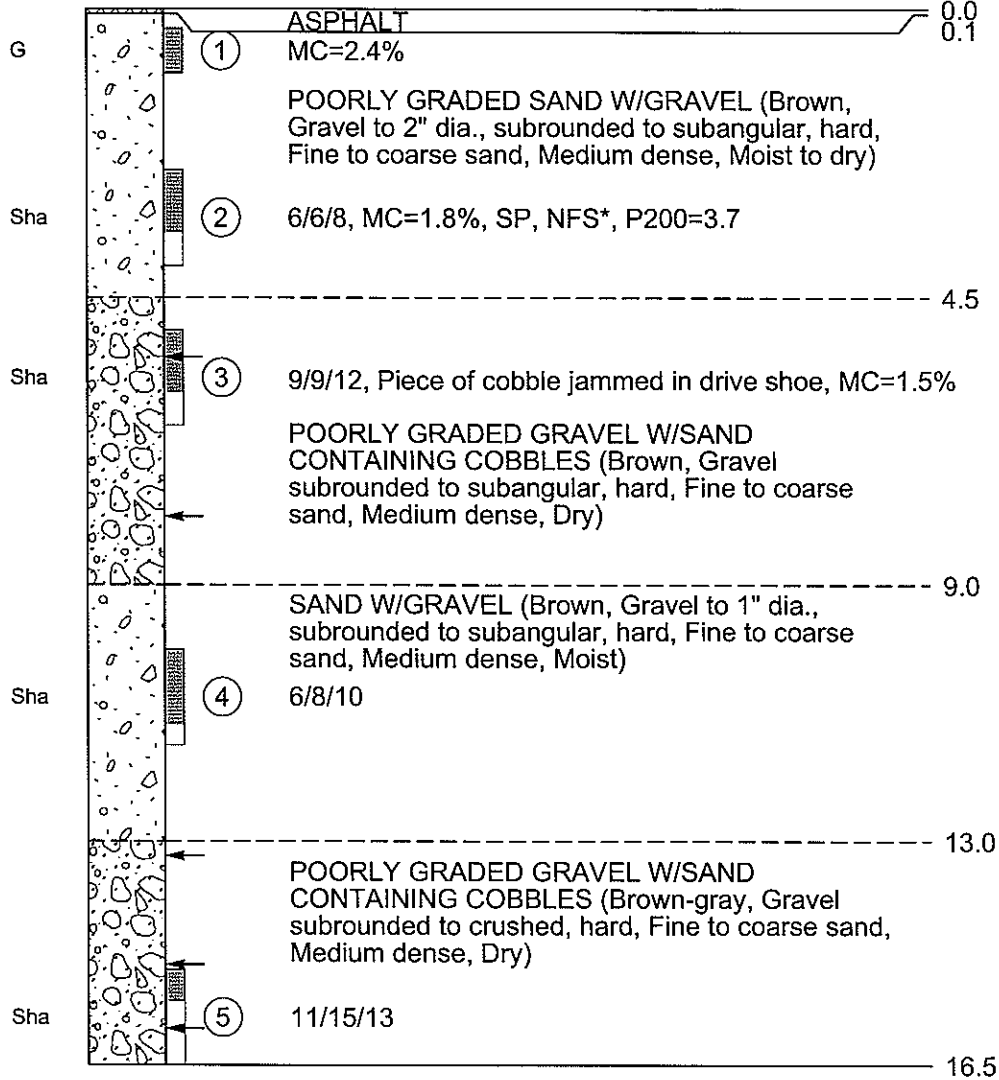
TB-10
 N 6,782,138
 E 338,709
 7/18/06

* Estimated Classification
 No groundwater was observed while drilling
 Coordinates are provided in UTM Format, WGS84 Datum, Zone 6V

Thirteen test holes (TB-08 to TB-20) were drilled in this segment. The subsurface conditions in this segment generally consisted of at least two feet of granular fill over a variable subgrade. The thickness of the granular fill varied from about two to 10 feet, and was approximately two feet thick in all but three of the test holes. The granular fill consisted of well to poorly graded gravel with silt and sand to sand with silt and gravel. The P200 ranged from 3.7 to 11.0 percent with an average of 7.0 percent. Moisture contents ranged from 2.4 to 4.0 percent. Variable soils underlay the granular fill, these soils ranged from fill consisting of silty sand and gravel to natural soils consisting of silty sand and sandy silt. Including only test results from the upper 10 feet, the percent passing the No. 200 sieve (P200) ranged from 5.0 to 73 percent with an average of 22 percent. Moisture contents ranged from 2.9 to 15 percent.

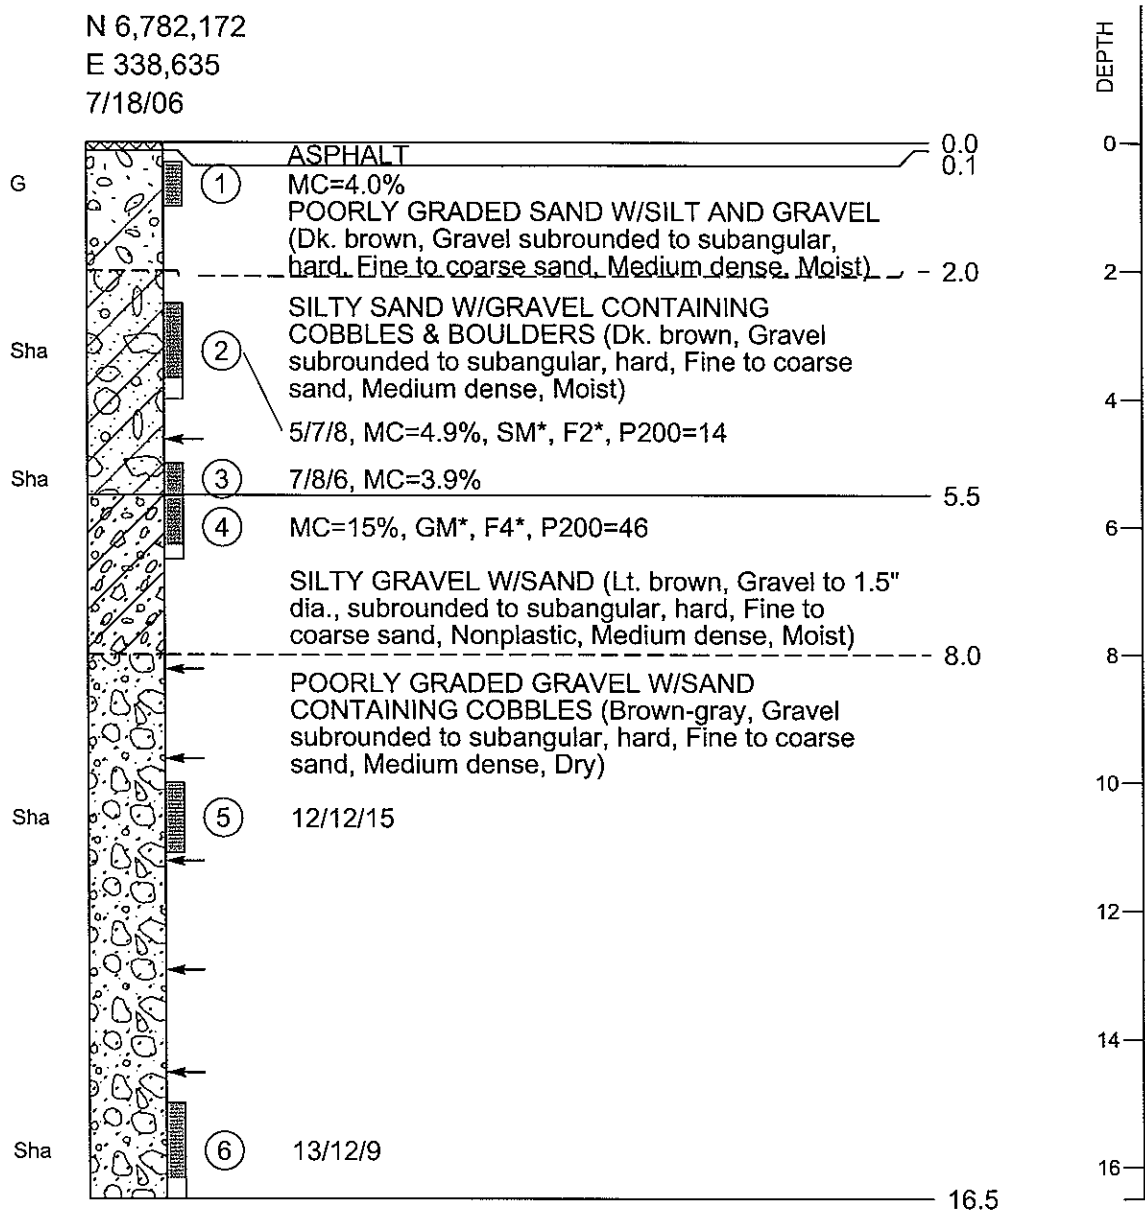
TB-11
 N 6,782,172
 E 338,635
 7/18/06

* Estimated Classification
 No Groundwater was observed while drilling
 Coordinates are provided in UTM Format, WGS84 Datum, Zone 6V

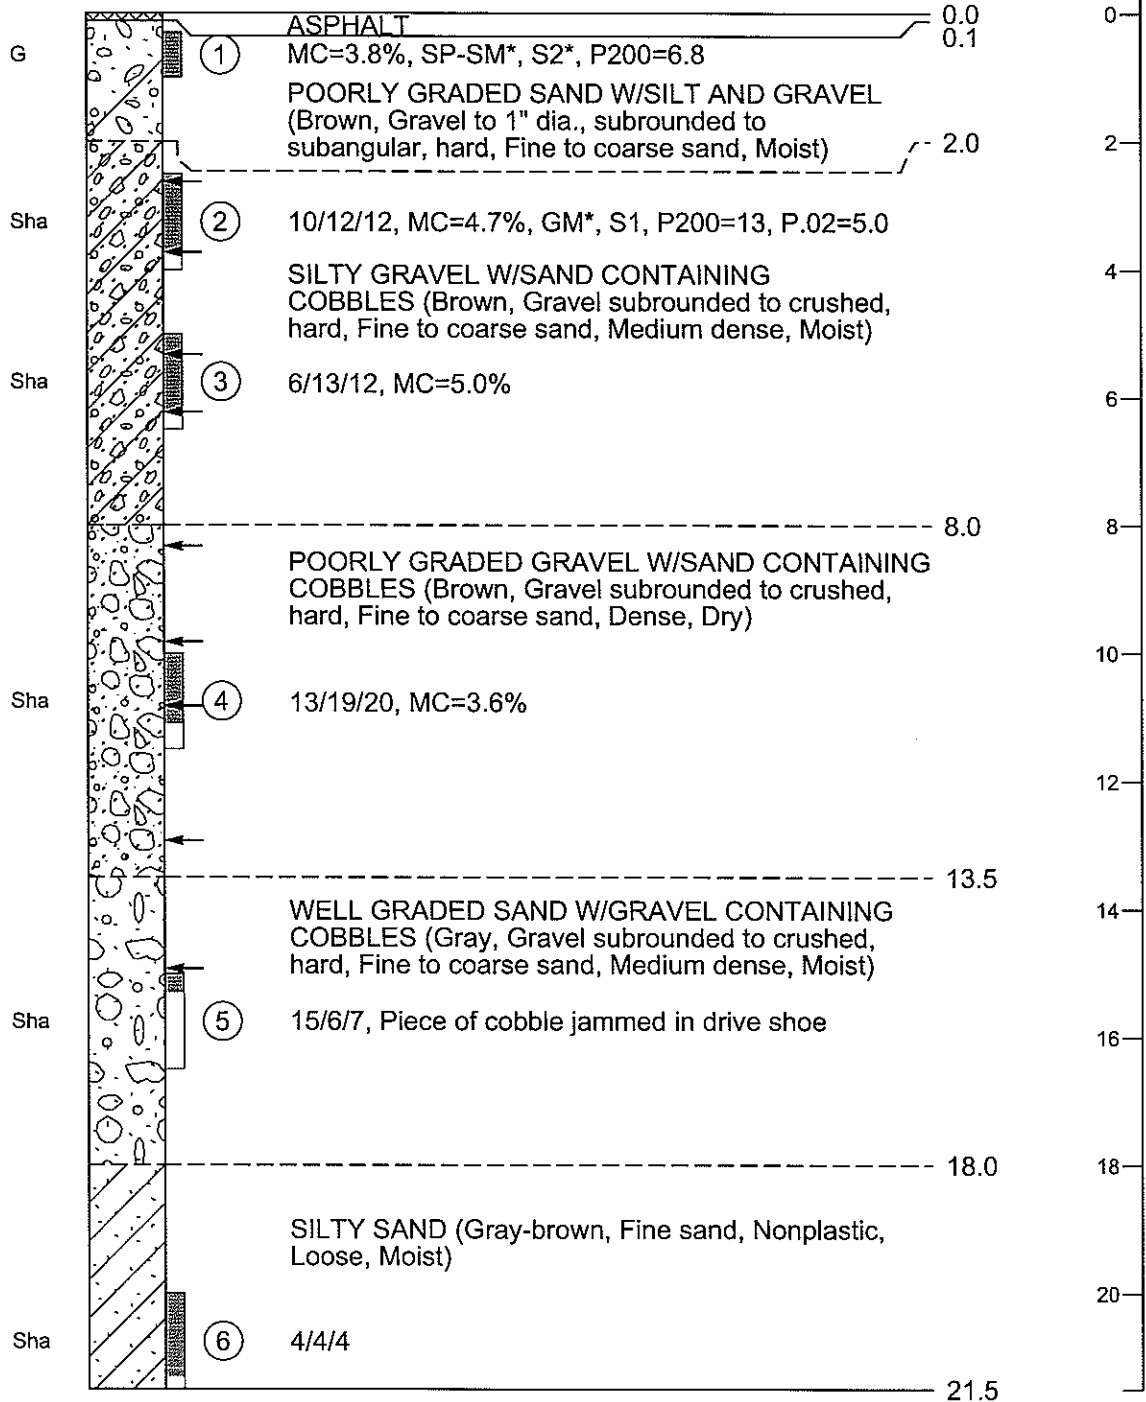
TB-12
 N 6,782,206
 E 338,577
 7/18/06

* Estimated Classification
 No groundwater was observed while drilling
 Coordinates are provided in UTM Format, WGS84 Datum, Zone 6V

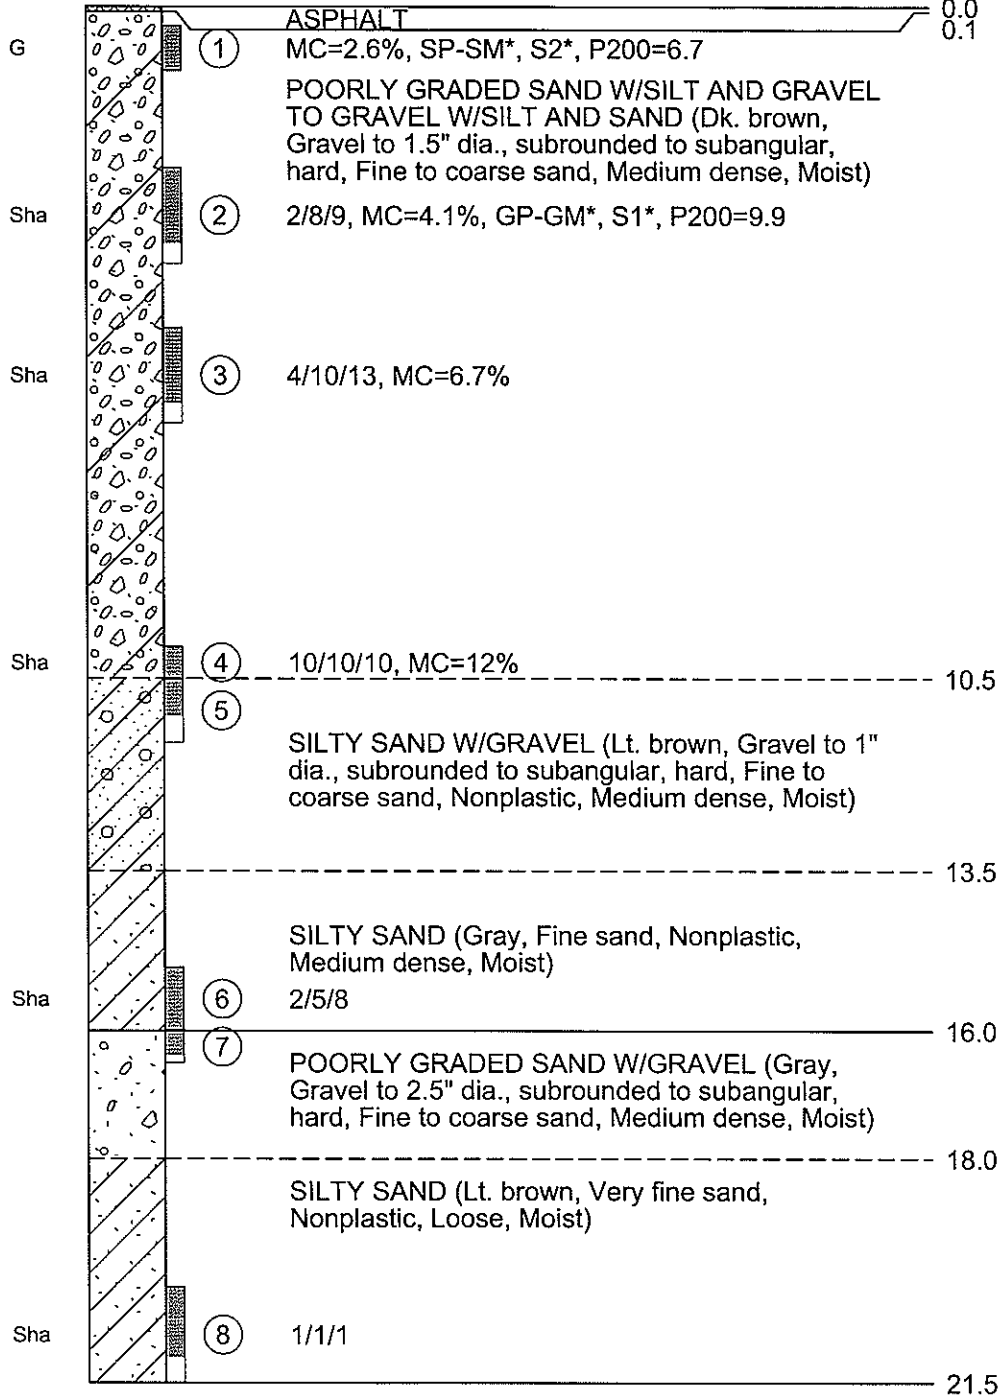
TB-13
 N 6,782,207
 E 338,562
 7/18/06

* Estimated Classification
 No groundwater was observed while drilling
 Coordinates are provided in UTM Format, WGS84 Datum, Zone 6V

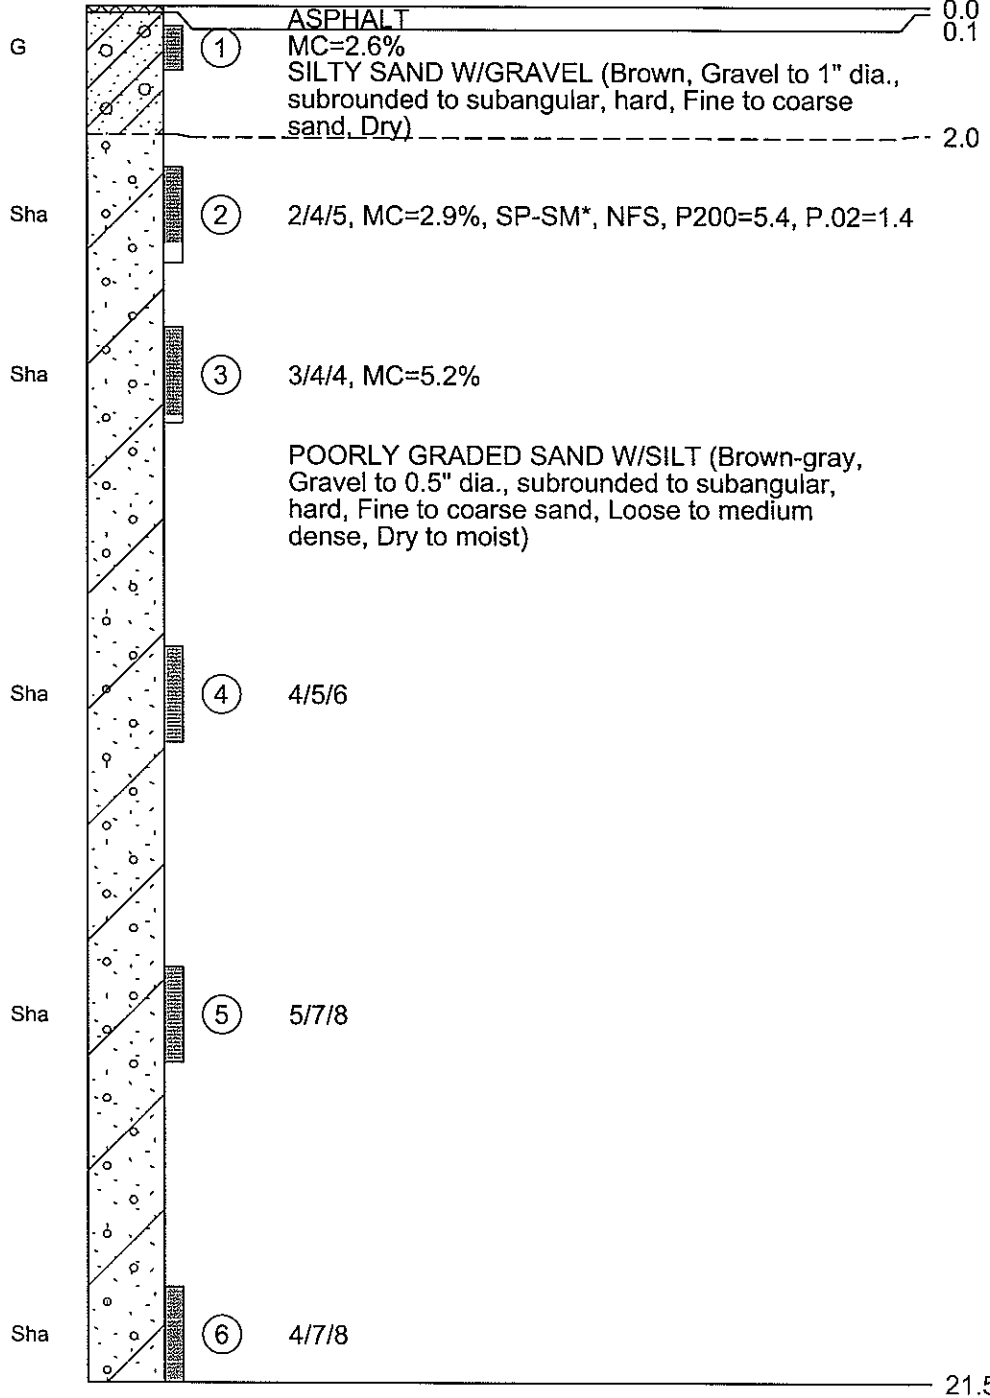
TB-14
 N 6,782,268
 E 661,435
 7/18/06

* Estimated Classification
 No groundwater was observed while drilling
 Coordinates are provided in UTM Format, WGS84 Datum, Zone 5V

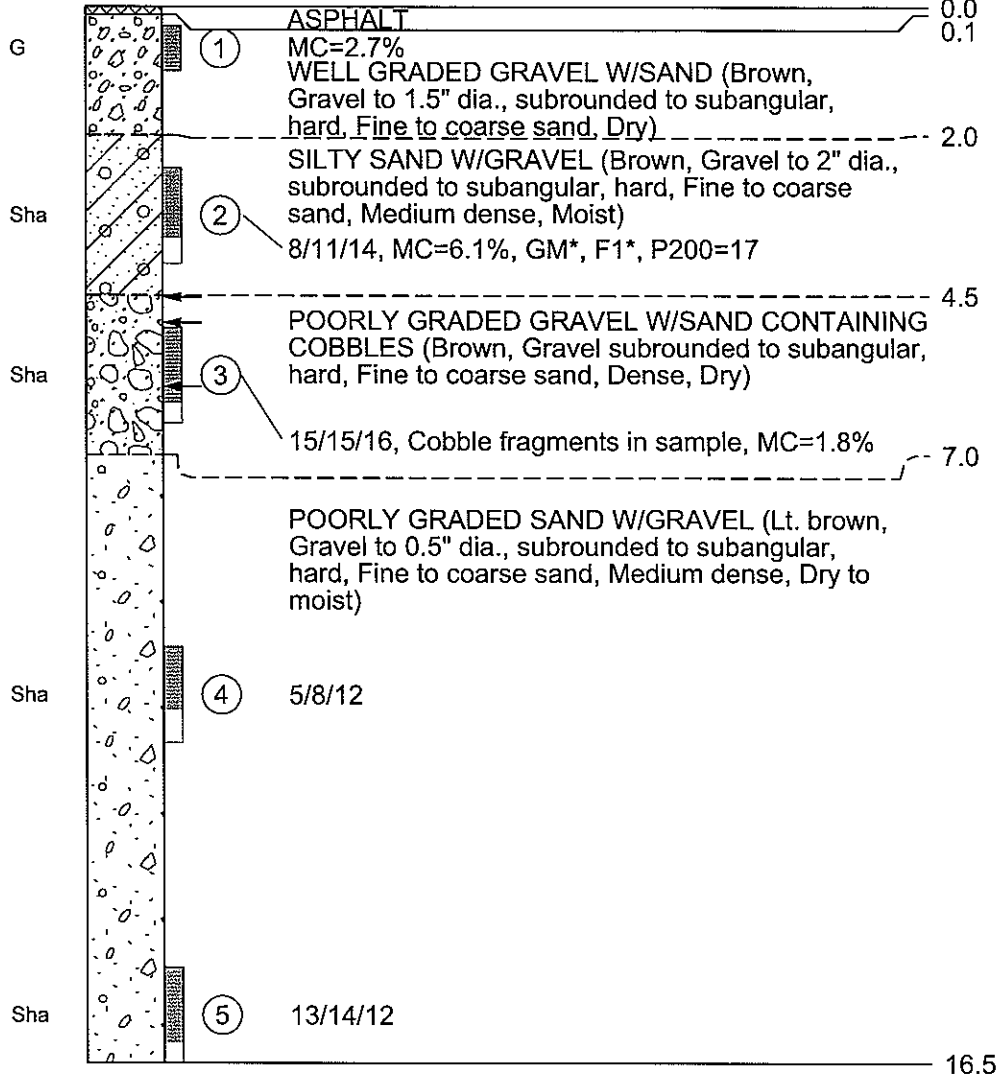
TB-16
 N 6,782,373
 E 661,011
 7/19/06

* Estimated Classification
 No groundwater was observed while drilling
 Coordinates are provided in UTM Format, WGS84 Datum, Zone 5V

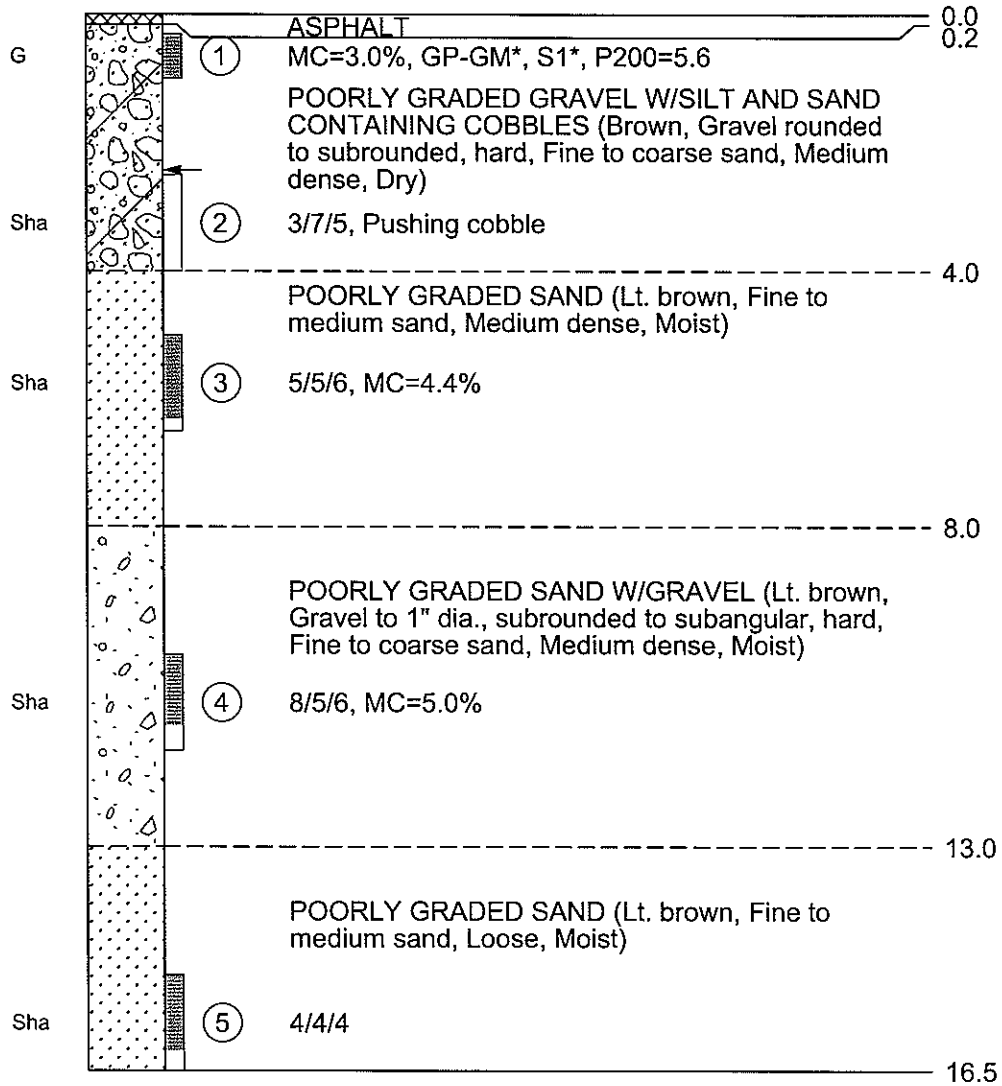
TB-17
 N 6,782,377
 E 661,101
 7/19/06

* Estimated Classification
 No groundwater was observed while drilling
 Coordinates are provided in UTM Format, WGS84 Datum, Zone 5V

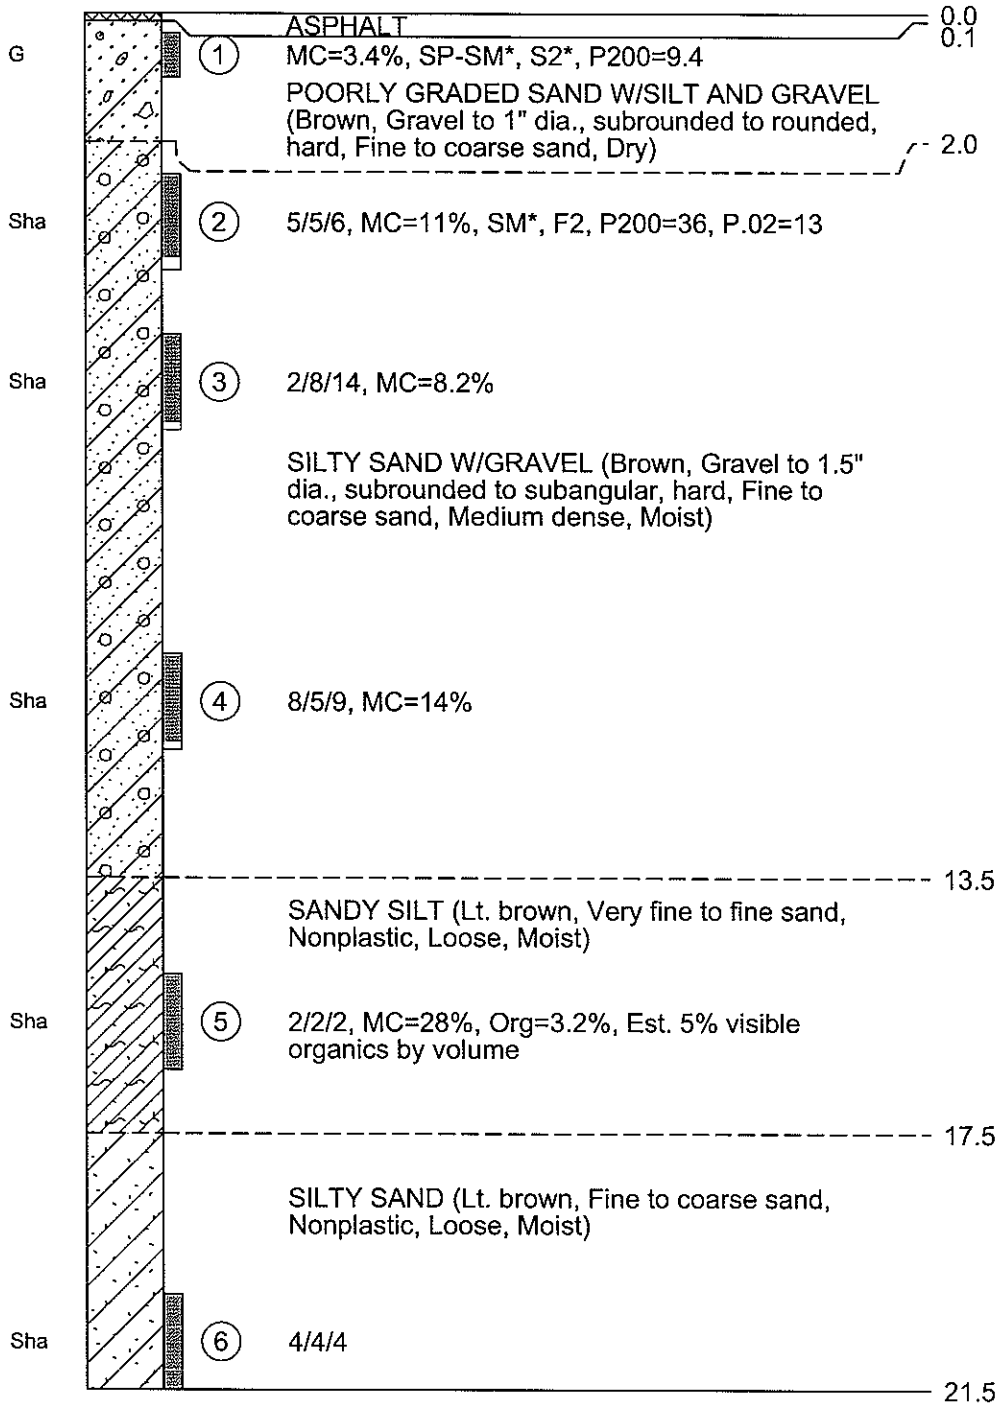
TB-19
 N 6,782,323
 E 661,283
 7/19/06

* Estimated Classification
 No groundwater was observed while drilling
 Coordinates are provided in UTM Format, WGS84 Datum, Zone 5V

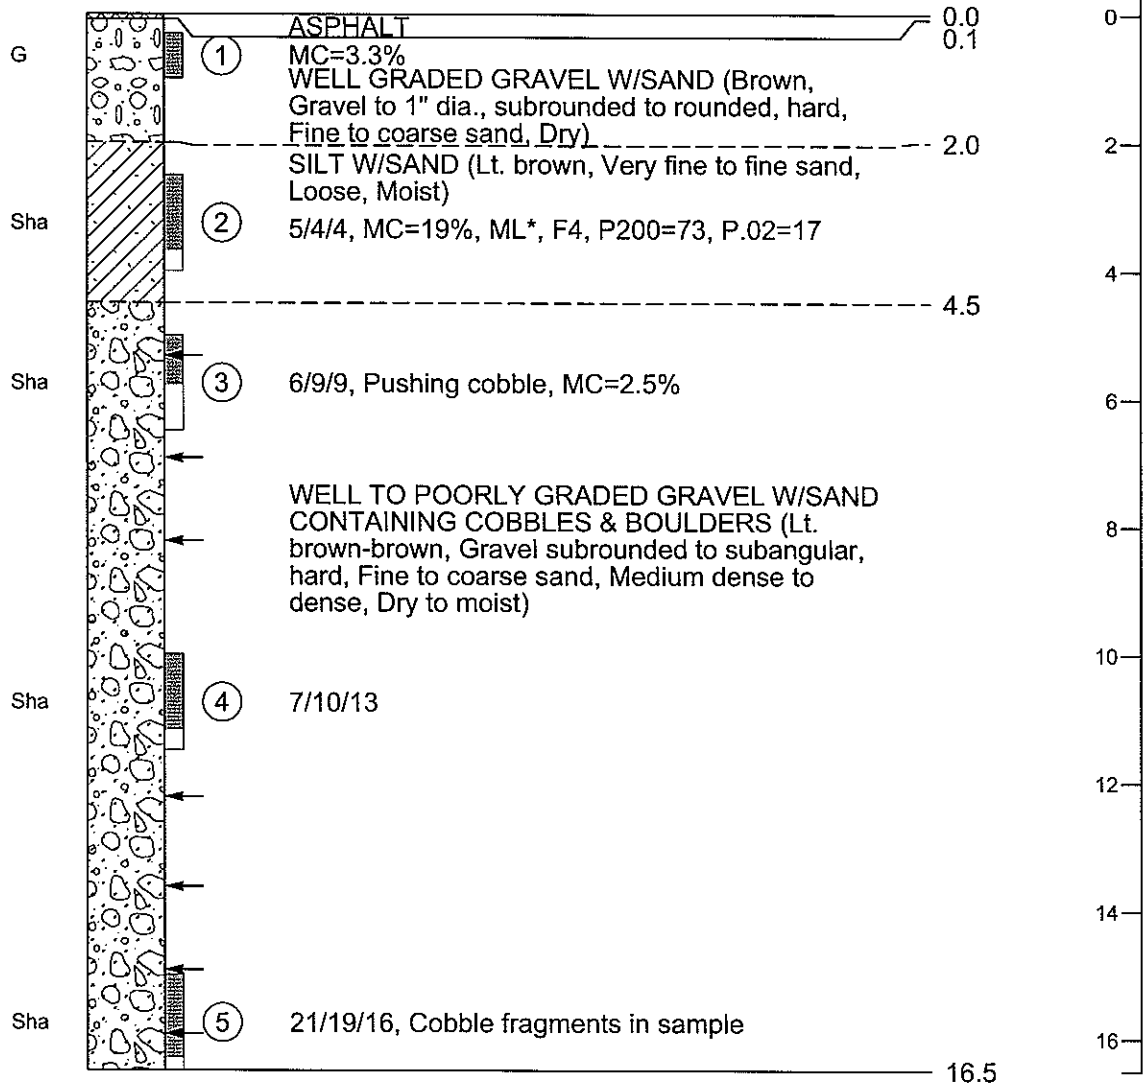
TB-20
 N 6,782,297
 E 661,374
 7/19/06

* Estimated Classification
 No groundwater was observed while drilling
 Coordinates are provided in UTM Format, WGS84 Datum, Zone 5V

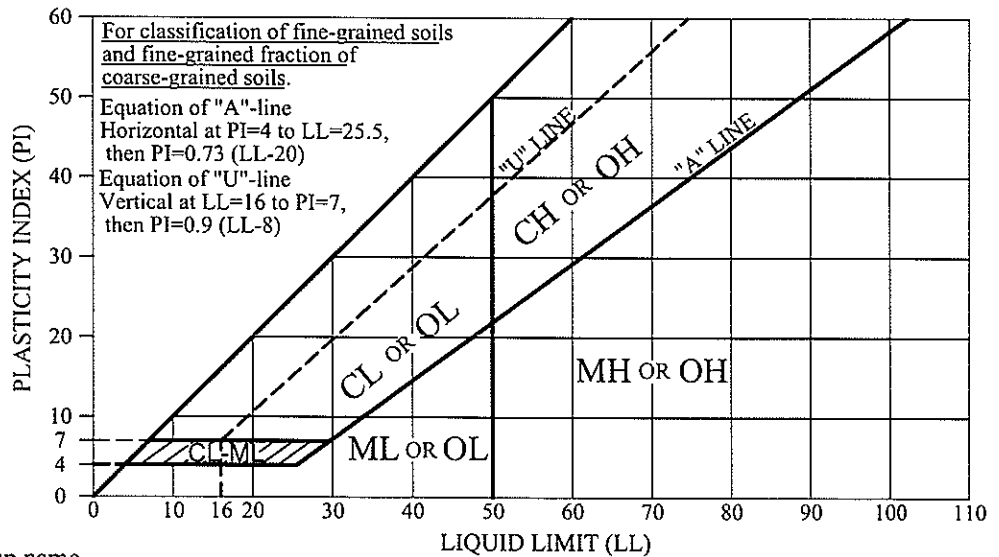
^P PI plots on or above "A" line.

^Q PI plots below "A" line.

A summary of the laboratory test results is provided in Appendix C, Drawings C-03 and C-04. The Unified Soil Classification System and Frost Design Soil Classification are presented on Drawings C-01 and C-02, respectively.
